## From Corrosion to Confidence

### How PSS Ceramic Rotors Transformed Fleet Maintenance.

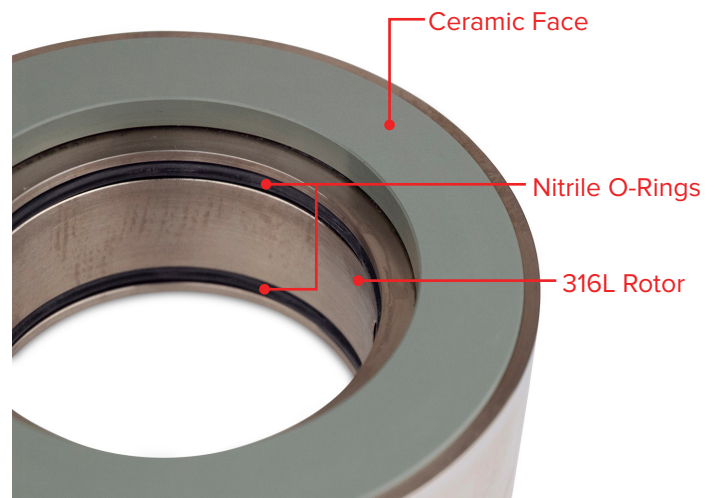
To address these challenges, PSS Seals, LLC installed a new ceramic face and rotor assembly (Part #07-300-CER) on the client's vessels.

- The ceramic rotor provided superior corrosion resistance and durability compared to stainless steel.
- The lifespan of the PSS Shaft Seal was significantly extended, reducing the frequency of replacements and costly maintenance.
